ANPP CORROSION PROGRAM

Loop Testing of Inconel,
Nickel, Monel and Bimetal
Heat Exchangers

MND-E-2681

December 1961

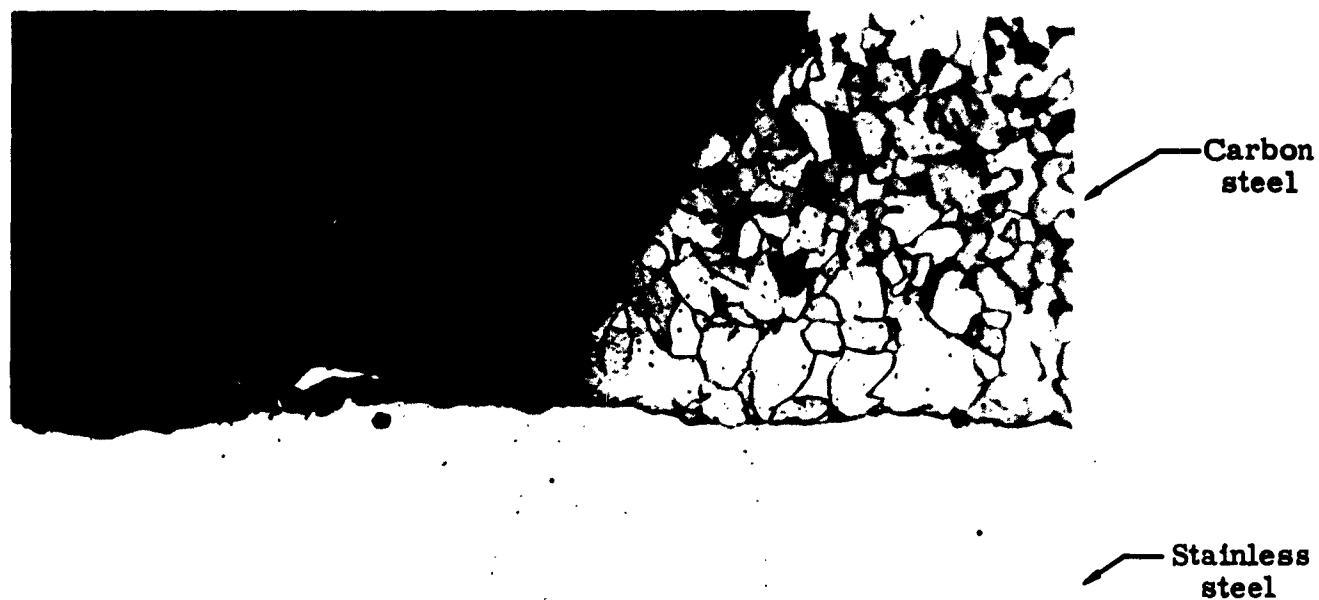
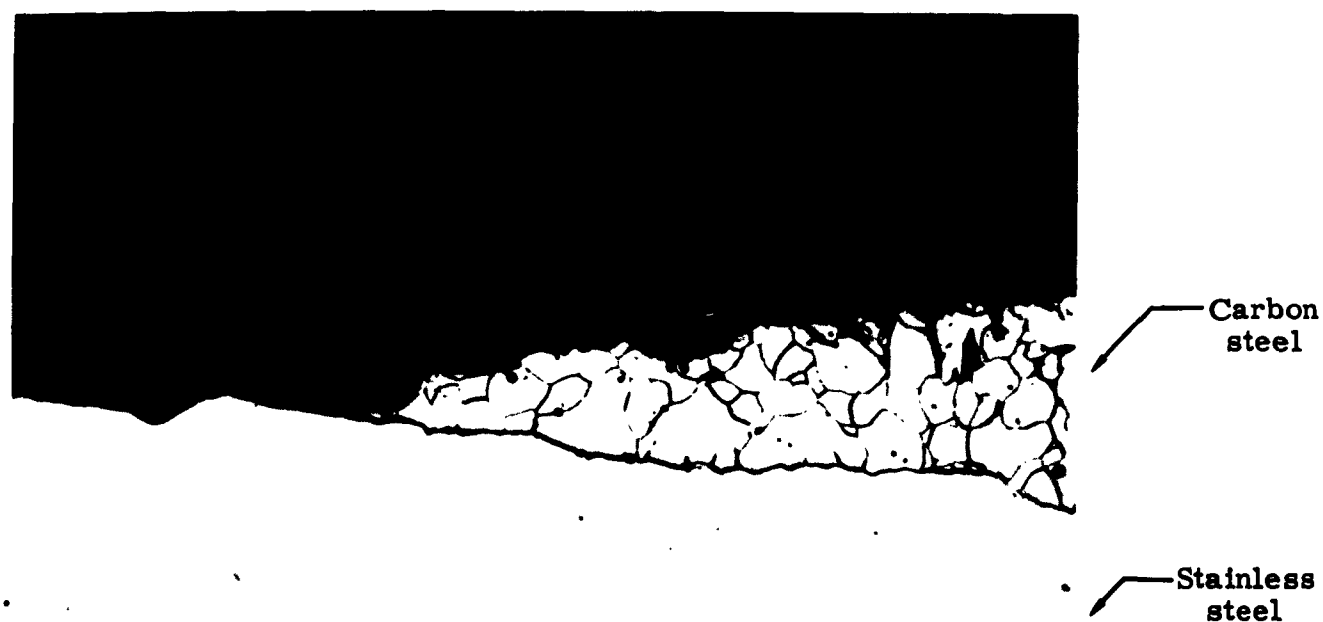
a. Defect in steam phase

b. Defect in water phase

Fig. 26. Photomicrographs of Defected Areas on MIN 16 Tubing
(Note that the stainless steel was relatively unaffected)

The tubing in MIN 16 was purposely defected by exposing the stainless steel sublayer as is illustrated in Fig. 24. Figure 25 shows one of the defected areas exposed to the liquid phase before cleaning. It was impossible to show a defected area in the vapor phase because of the very heavy layer of corrosion products. Figure 24 shows the tubing after cleaning. The defects and extent of corrosion are clearly visible. Gross amounts of the low carbon steel clad were corroded away. Metallographic sections from the areas of the defects revealed no detrimental effects, as far as the stainless steel was concerned. Typical photomicrographs are shown in Fig. 26. The most striking result of the tests with MIN 15 and 16 was the excellent resistance of the submerged low carbon steel tubing to the unusually severe conditions. This is illustrated in Fig. 24 and also in Fig. 26 which shows that in the liquid phase the tapered carbon steel portion of the defect is still present. In the vapor phase (Fig. 26-b) the portion has completely corroded away.

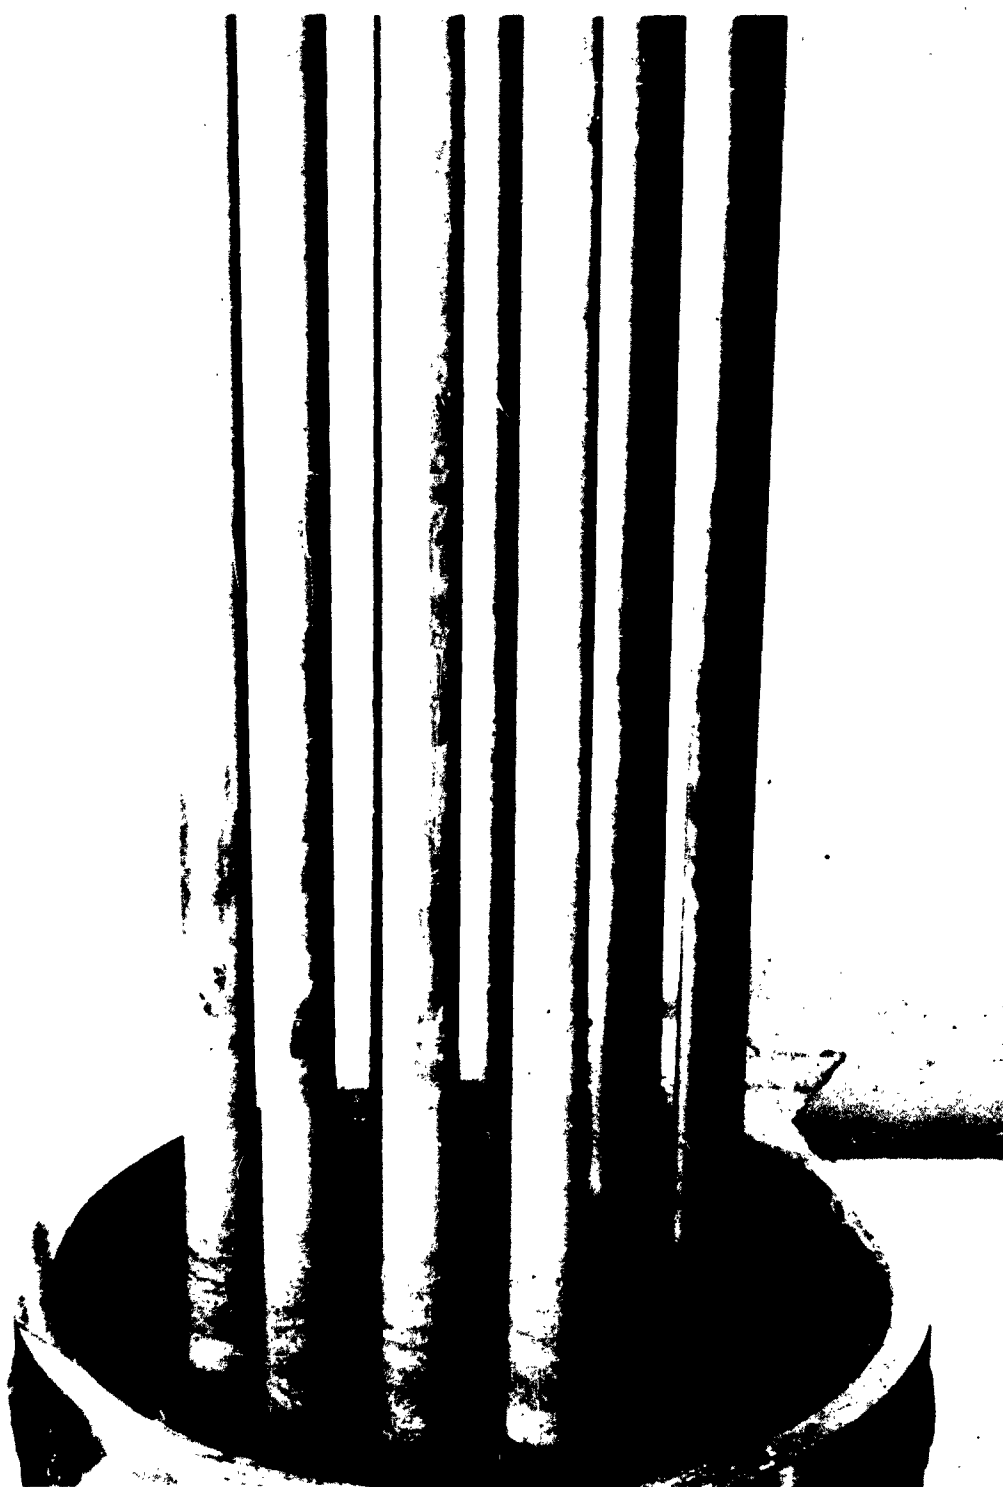
Fig. 36. MOD-SH-7--Appearance After 4747 Hours of Testing
